# The restoration of the *Domus* of the *Mithraeum* of the *Painted Walls*: a methodological approach

Barbara Davidde Petriaggi, Maria Grazia Flamini, Roberto Petriaggi, Giuseppina Fazio, Antonella Altieri  
Istituto Superiore per la Conservazione ed il Restauro, Rome, Italy

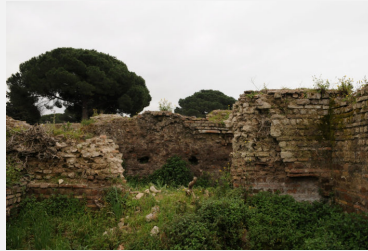
A view of west side before restoration work

A view of east side before restoration works

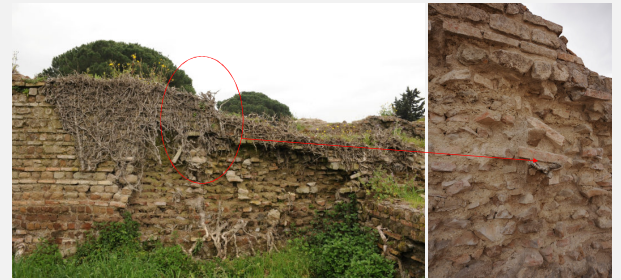
Stems wood of ivy plants, climbing with adventitious roots, are one of the main conservative problems in the site. The restoring treatment included its gradual cutting and removal

The utmost attention has been devoted to technical procedures, and recognized and tested technologies and products - improved during a pilot restoration project - have been utilized, in order to achieve both minimal intervention, as indicated by Brandi, and maximum reversibility. The restoration works which ended in June 2013, consolidated and strengthened the ancient walls and improved their resistance to atmospheric agents through the use of protective masonry capping. The decision to limit reintegration work to the minimum, made it possible to identify the ancient phases of the palimpsest walls, as well as the numerous former and mostly preserved restoration interventions. Every action has been carried out without ever concealing what is in existence, and without altering the information destined for subsequent specialized research into the complicated historical events and restorations. This methodological approach of extreme care and respect has proved to be much more necessary in the presence of fragile and delicate elements such as the archaeological walls; neither exaggerated nor inadequate nor burdensome, the commitment of the experts has found expression in a new moment of care towards cultural properties of inestimable value, until now often treated as objects of no value.
