The restoration of the Domus of the Mithraeum of the Painted Walls: a methodological approach

Barbara Davidde Petriaggi; Maria Grazia Flamini; Roberto Petriaggi; Giuseppina Fazio; Antonella Altieri

Istituto Superiore per la Conservazione ed il Restauro, Rome, Italy

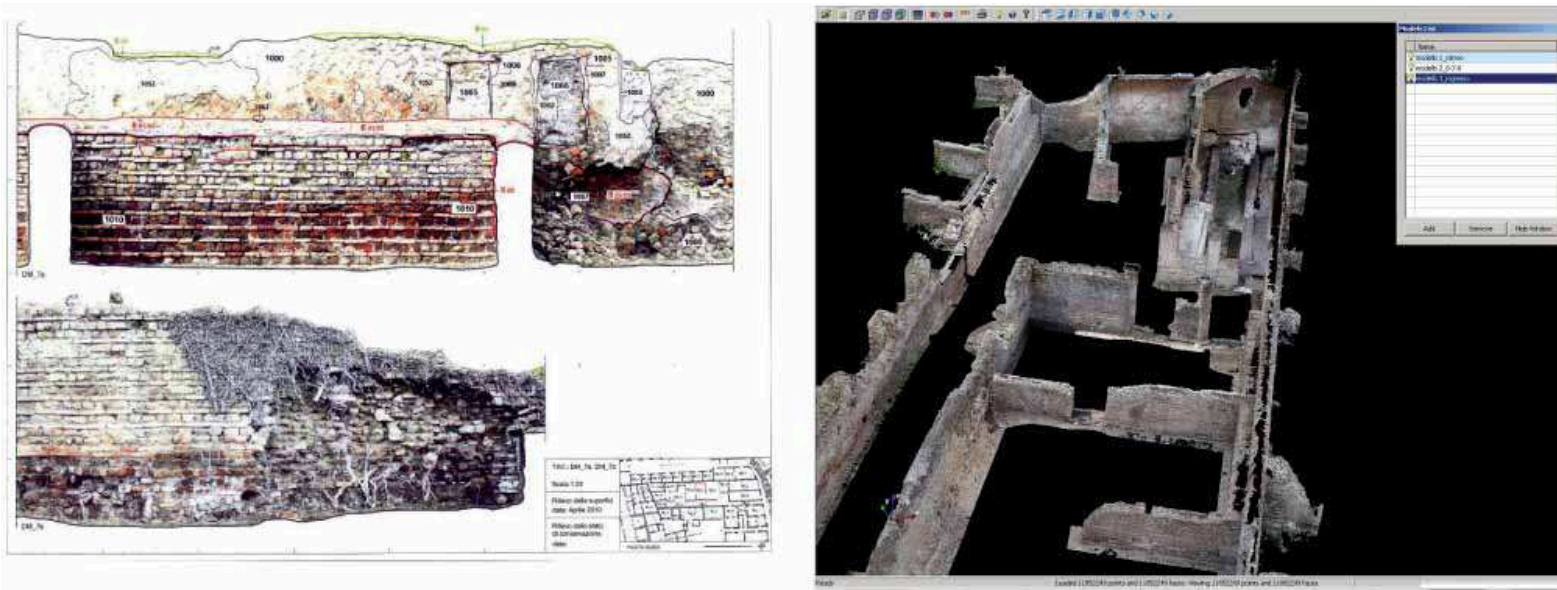
Fig.2 - A detail of the stratigraphic study on the masonry palimpsest of the wall in opus incertum positioned along the west side; a detail of the laser scanner model of the Domus

The restoration work was preceded by the analysis of the masonry, laser scanner documentation and the study of archival documents. In particular, the data acquired in the 1939 excavations, the 1950-51 excavation reports by Italo Gismondi, and the publications of Giovanni Becatti, have been correlated with the modern stratigraphic analysis of the surfaces that had emerged and have all been re-examined from a critical viewpoint.

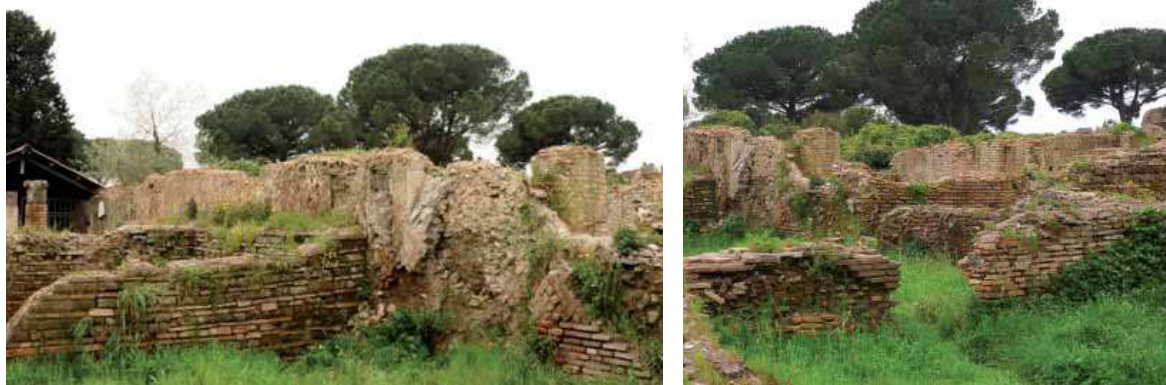
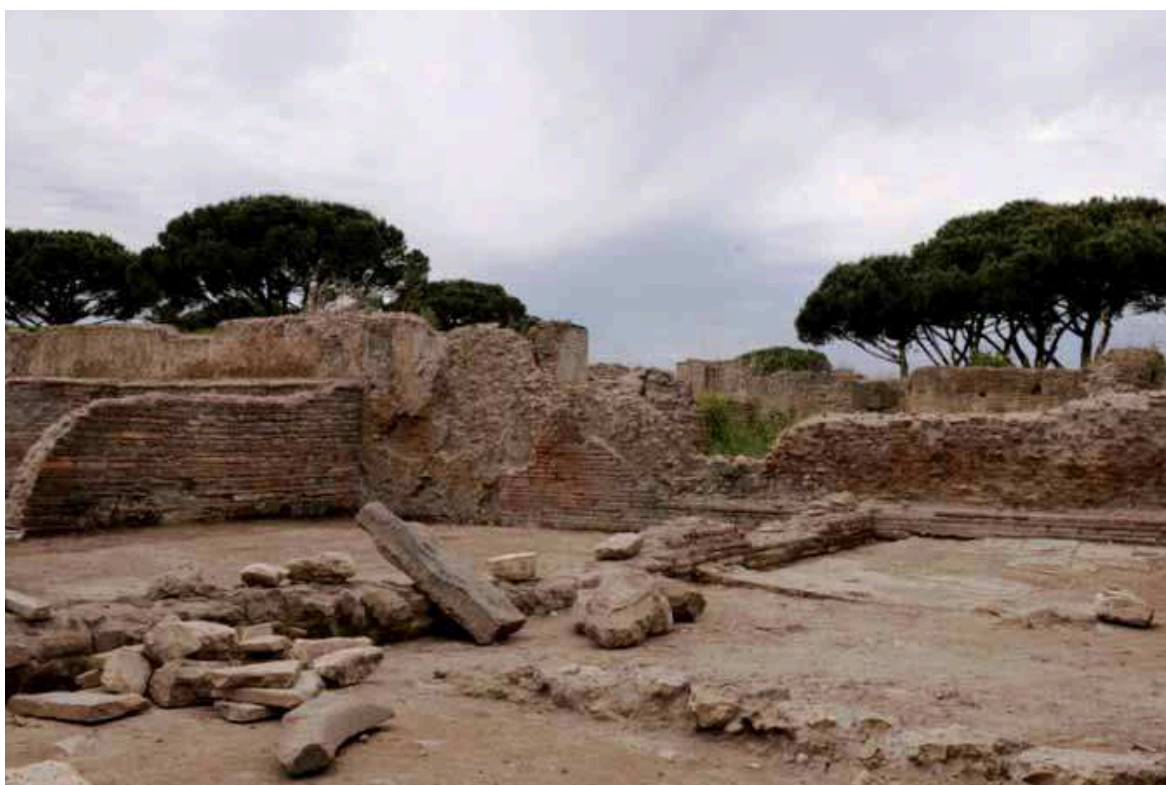
Fig.3 - Views of west side before restoration works

A view of west side after restoration works

Graphic documentation was obtained in which the diverse forms of alteration have been summarized and made immediately evident. What becomes clearly apparent is the serious level of the problem of fragmented wall capping, much of which is covered with ivy; also serious but localized is the loss of the brickwork lining and consequent exposure of the internal masonry nucleus, which corresponds to the phenomenon of disintegration of the mortars. Where masonry structures of different periods have been built up against each other, there are cracks and detached parts; unevenly distributed disintegration of the brickwork is also evident, and so on. Through the assessment of its particular

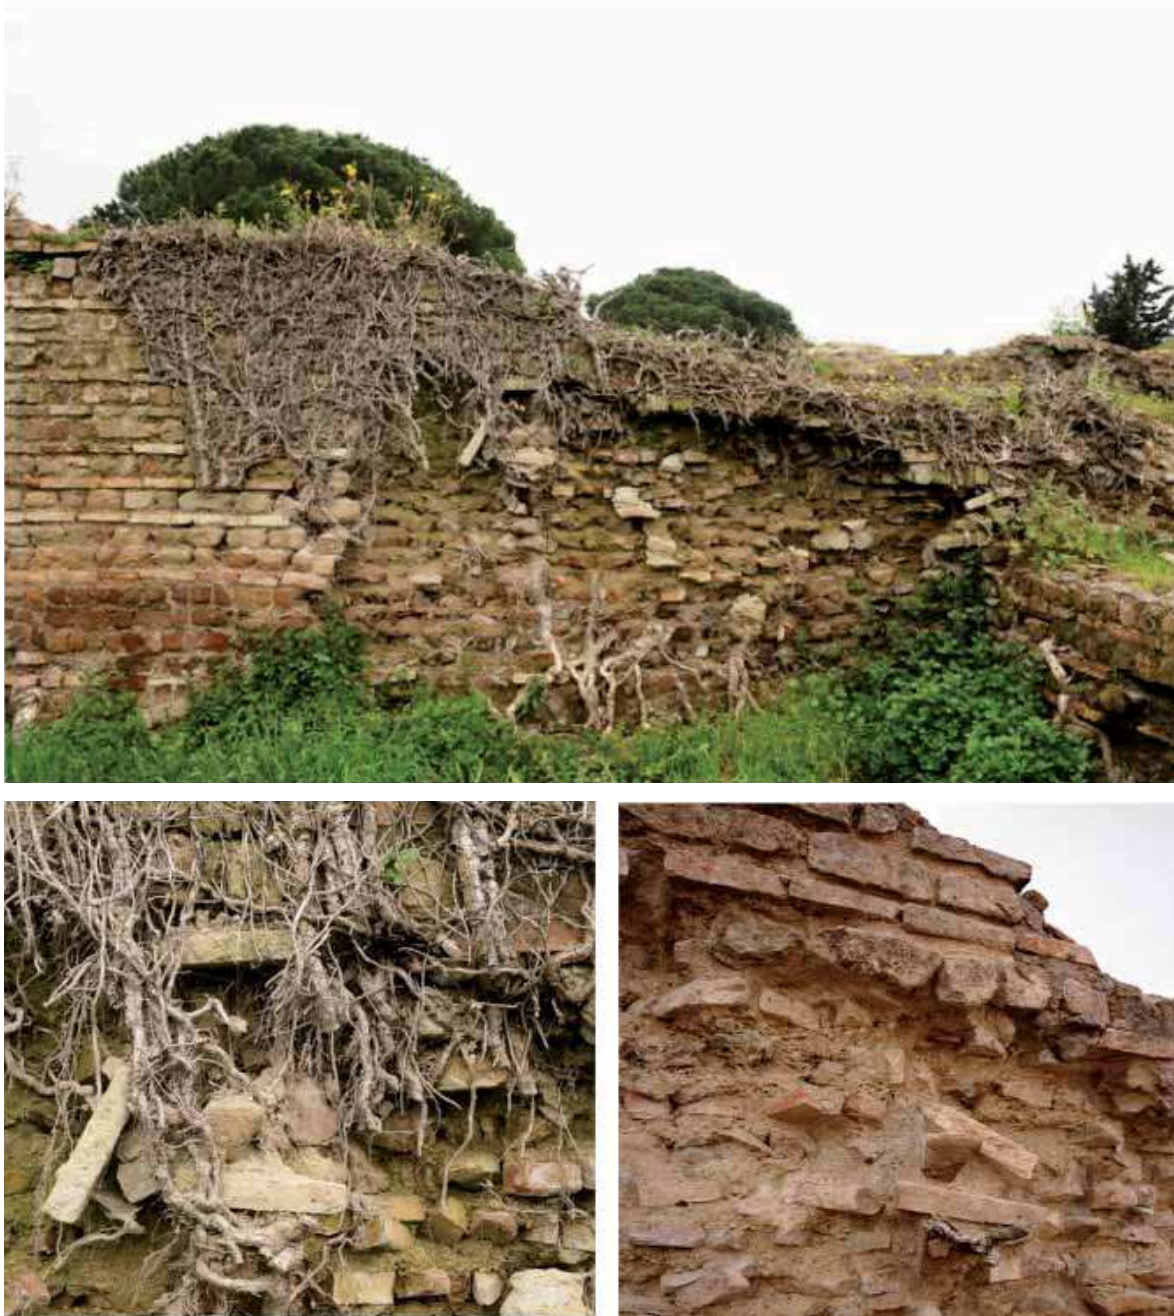
Fig.4 - Plants constitute one of the main conservative problems: restoration treatment include their gradual cutting and removal without causing further damage while this operation is carried out. In some points remains of stems incorporated in the wall structure were maintained for static reasons; East side wall detail before and after restoration works

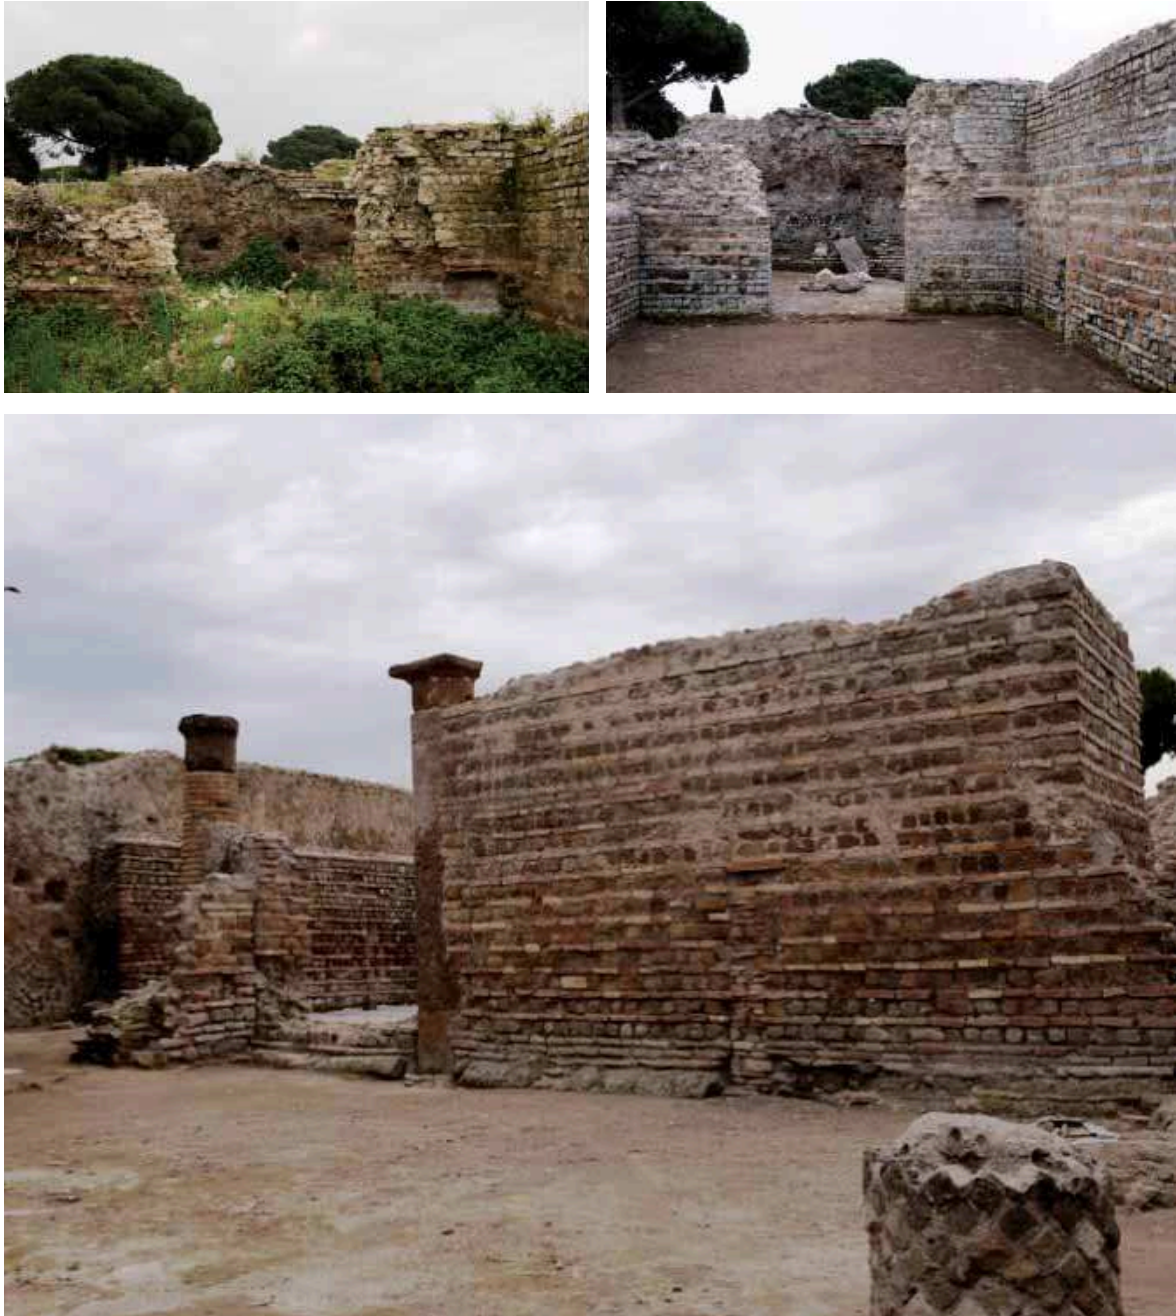
Fig.5 - A view of east side before and after restoration works; a view after restoration works

destined to function as “materials of sacrifice” to the re-presentation of the causes of alteration - they consist of hydraulic mortars made up of lime, pozzolana and cocchiopesto, of varying grain sizes and fluidity adapted for filling and reintegration; also by completing sequences of operations controlled according to specific needs, from the devitalisation and progressive elimination of plants to the removal of totally pulverized portions of mortar, the regeneration of those that are recoverable, the re-laying of loose and detached bricks, and the re-establishment of lines of wall capping. The job of the micro-consolidation of the mortars lacking in cohesion is the only operation that has seen the use of a different product like ethyl silicate.

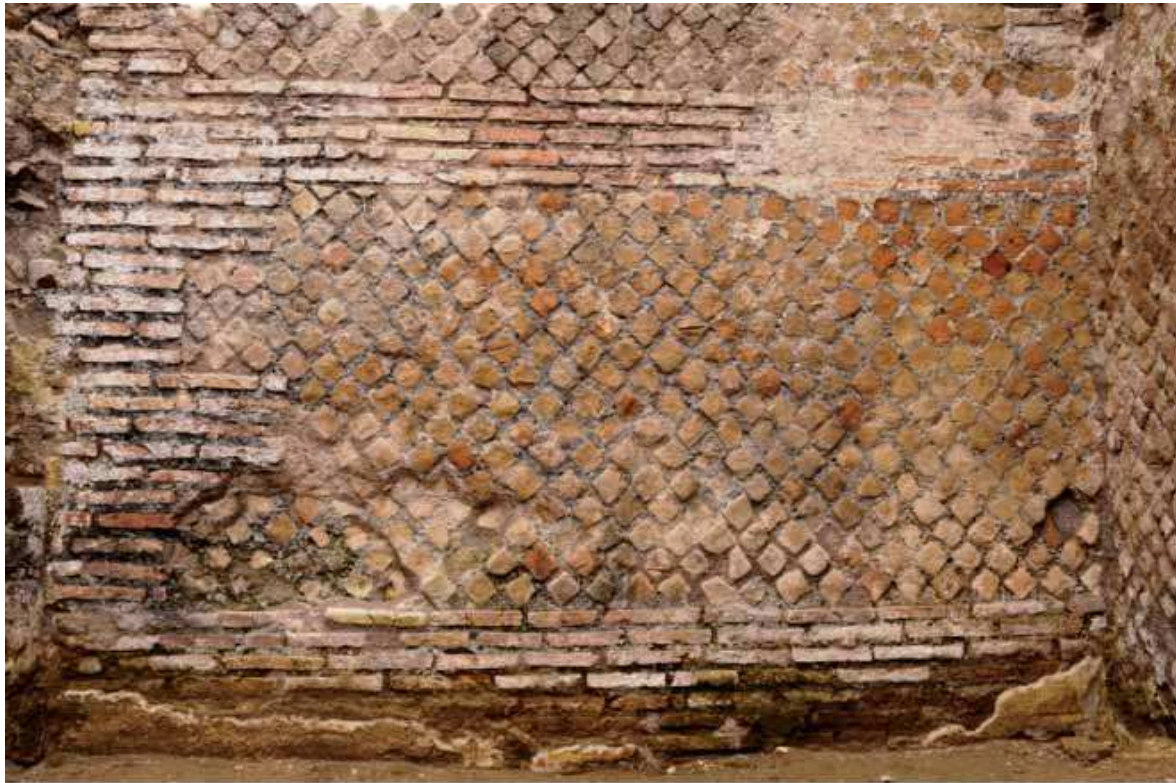
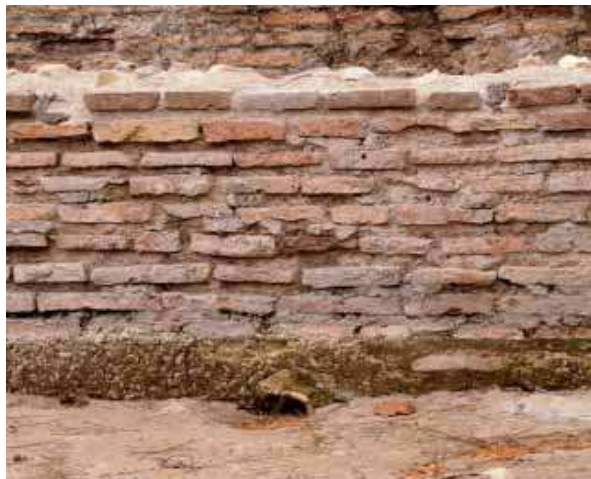
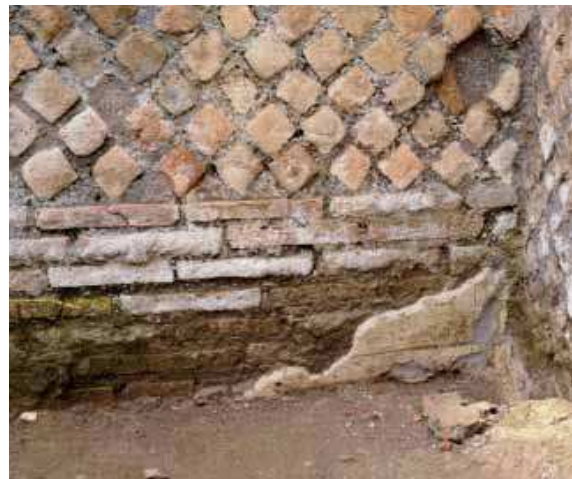
Fig.6 - South side wall after restoration works; remains of a wall at the end of restoration works; remains of south side wall at the end of restoration works
